**Date:** May 2, 2017

**From:** Walter Remmert, Director  
Bureau of Ride and Measurement Standards  
Pennsylvania Department of Agriculture

**Subject:** **Investigative Report**  
**Amusement Ride Reopening Requirements**  
**Amusement Ride: *Rollo Coaster***  
**PA Ride ID Number: 1209**  
**7 PA Code § 139.11(c)(2)**

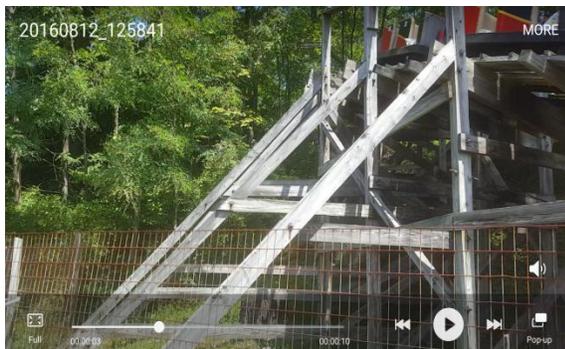
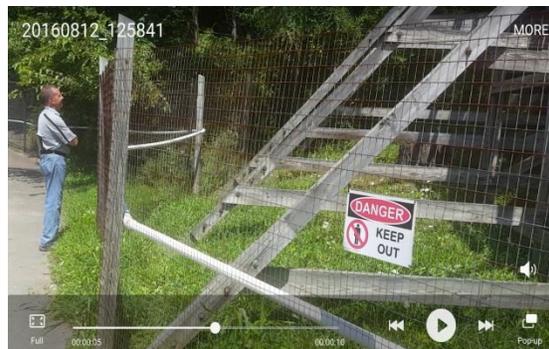
Photo “E” Structural restraints for track

31. A structural support cable running to the beginning of the curve in question was observed to be loose and sagging. The turnbuckle to cable is rusted with no jam nut (Photo “E”).

32. Video of a trial run shows movement in the turn where the incident occurred. The video includes the insurance investigator observing as the train goes through the curve (Video – Coaster run with sandbags [1]).
